# American Dream Home Inspection, LLC

Re: 1234 N. Mainstreet  
Glen Ellyn, IL. 60137

## REPORT SUMMARY

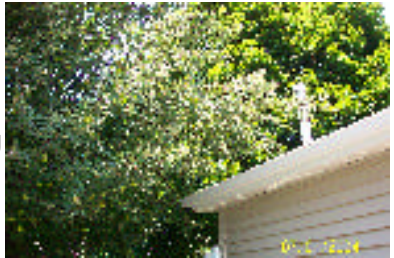
**Trees Condition:** Satisfactory - The trees on the site all appear to be alive and in acceptable condition. Trees overhanging the garage structure need to be trimmed so that limbs, leaves, and rain will not drop off the tree onto the roof covering and clog the gutters, damage the roof, or promote moss growth. Trees that rub against the roof can cause severe damage and can drastically reduce the life of the roofing material.

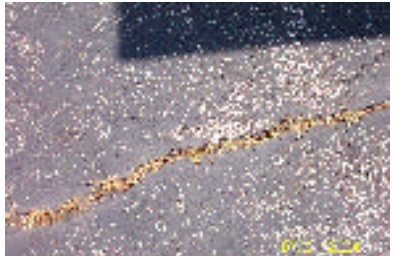
**Driveway Condition:** **Action Necessary** - The driveway needs action. Repair or replacement is indicated. The driveway is broken into segments. This is unsightly and likely to continue movement.

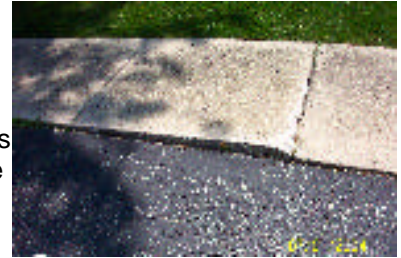
**Action Necessary** - The walkways need action. Repair or replacement is indicated. There is heaving noted in the walkways that needs to be repaired to prevent further deterioration or a trip hazard. Broken segments in walkways are unsightly and likely to continue movement.

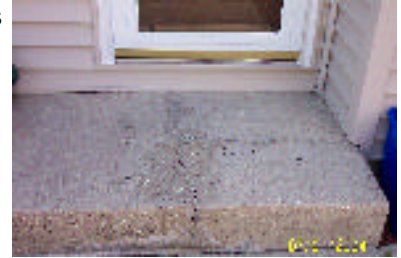
**Attention Needed** - The entryway stoop needs some minor repair in order to defer deterioration. The stoop has cracks in it.

The unevenness of the sidewalk & walkway pose a safety problem.

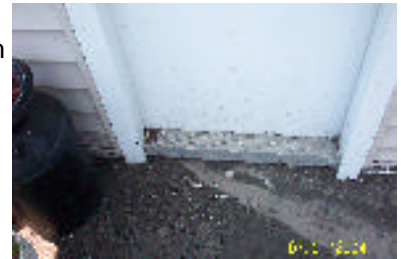
**Attention Needed** - The run-off water from the retaining wall needs to be redirected away from the garage apron.

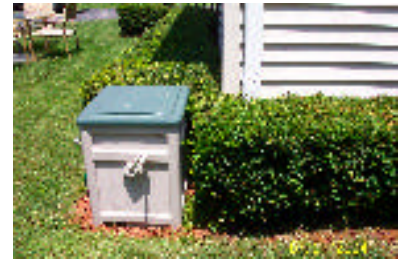
Due to limited visibility (shrubs) the external portion of the foundation is blocked from view and is not covered by this inspection.

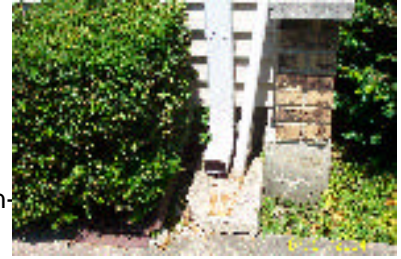
The gutter system on the roof edge appears to be functional and adequately sloped to carry the water to the downspouts. Installation of downspout extensions would help carry the water further away from the foundation. Run-off water needs to flow away from the side of the house at least 6 feet. This will allow the run-off to get far enough away to not interfere with the foundation.

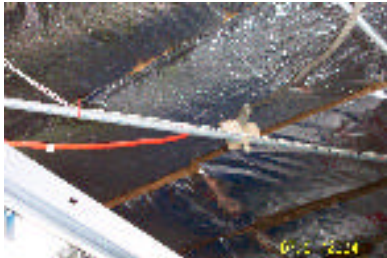
The current state of electric distribution in the garage is in need of repair in the vary near future.

**Action Necessary** - Some of the outlet & junction box covers are missing. Also extension cords were used to supply power to permanent fixtures.

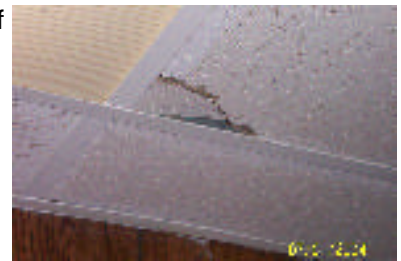
**Comments:** Some of the dropped ceiling tiles are in need of replacement.

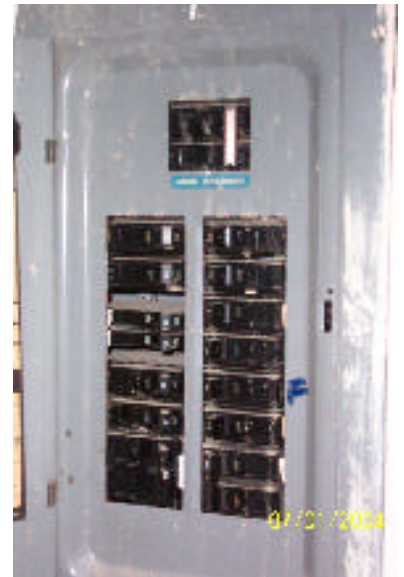
**Service Cable to Panel Type:** Copper.  
**Is Panel Accessible:** Yes - The electrical panel is in a location that makes it readily accessible.  
**Panel Condition:** **Action Necessary** - The power panel, as a container for safely covering circuitry and components, requires immediate action to minimize the possibility of electrical shock. There are open slots in the panel breaker where breakers are missing.

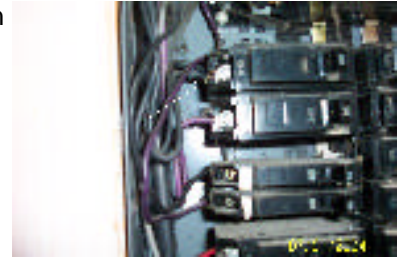
**Action Necessary** - Electrical circuitry wiring in the power panel shows some condition that calls for the immediate action of a qualified licensed electrician. There are two wires to a breaker or fuse. These need to be separated so that each wire will have its own breaker or fuse.

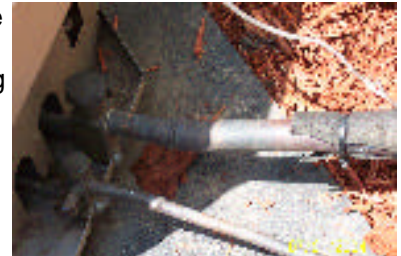
**Attention Needed** - The insulation wrap on the suction line to the condenser/compressor is in need of attention due to deteriorated or missing insulation.

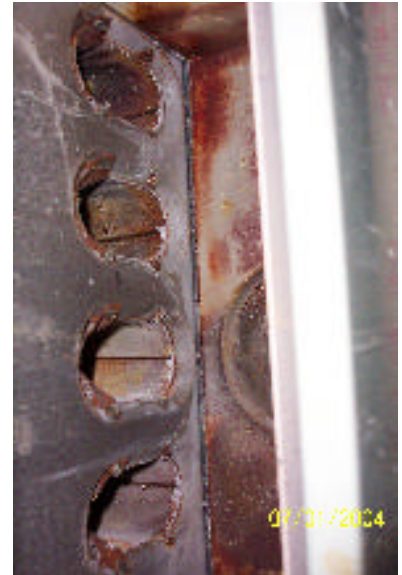
A visual inspection of the heat exchanger shows rust or other conditions exist which warrant further analysis and possible repair by a qualified licensed professional.

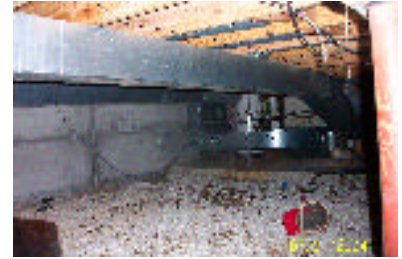
Exposed ductwork in unheated space is not insulated. The efficiency of the heating and air conditioning systems is greatly reduced due to the heat loss or gain. Insulation is strongly recommended. Ducts noted in the crawlspace do not appear to be insulated either from the interior or exterior of the duct run.

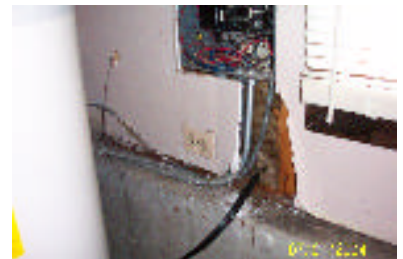
**Walls:** **Action Necessary** - There is a condition in the wall sheeting that needs to be repaired.

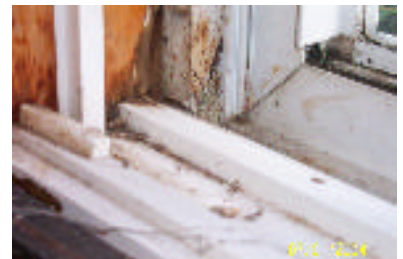
**Windows:** **Attention Needed** - There is evidence of leakage from at least one window. I recommend sealing the window frame and painting to prohibit further damage.

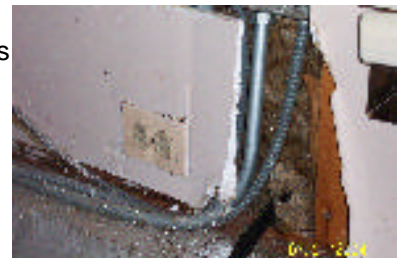
**Electrical Outlets:** **Action Necessary** - Electrical outlet in laundry room is a fire hazard and should be replaced as soon as possible.

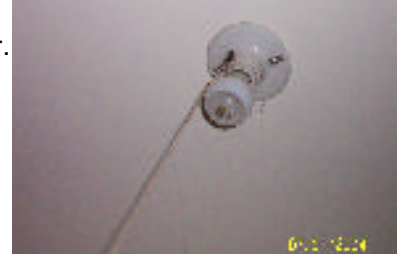
**Location:** 2nd Floor, Southwest side.  
**Entry Door:** Satisfactory - The entry door to this bedroom is functional.  
**Closet:** Satisfactory - The closet is functional and of average size. Exposed light blub without cover. This is a potential fire hazard. All items should be kept at least 18 inches away from the blub.

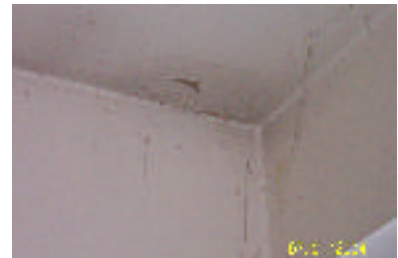
**Wall Covering Material:** sheetrock.  
**Walls:** Satisfactory - The walls in the bedroom appear to be satisfactory.  
**Ceiling:** **Attention Needed** - There is a condition in the ceiling that needs to have attention. There is evidence of an unrepaired stain on the wall caused by a prior moisture leak.
