# American Dream Home Inspection, LLC

Re: 1234 N. Mainstreet  
Glen Ellyn, IL. 60137

## REPORT SUMMARY

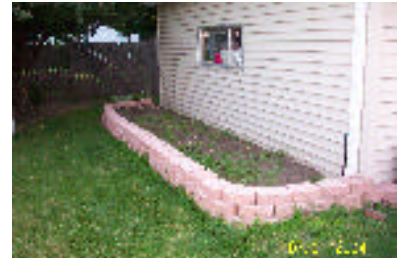
South side of garage.

The retaining wall is made of concrete masonry units.

Good - The retaining wall is in good or near new condition.

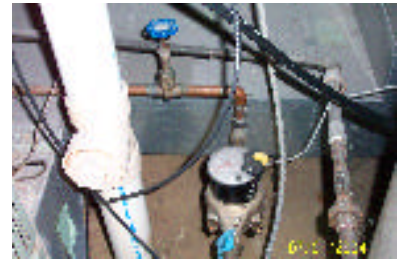
**Water Source:** City.  
**Water Meter Location:** Basement level in laundry room.

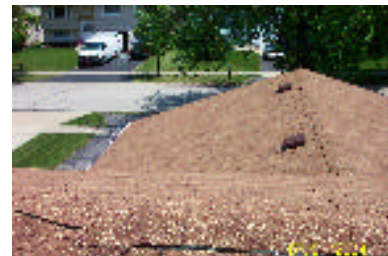
**Type Roof:** Combination of: Gable & Hip.

**Condition of Roof Covering Material:** Good - The roof covering material is either new or near new, and it appears to be installed correctly.

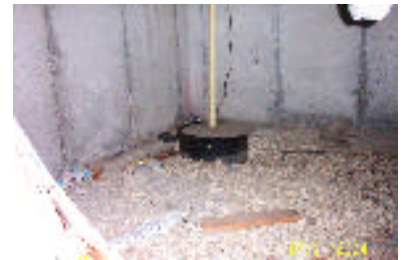
Yes. The pump appears functional.

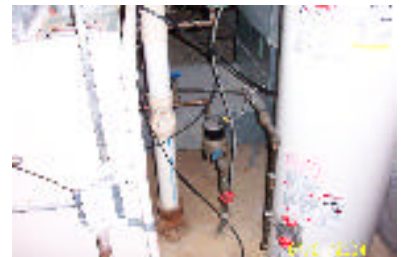
Yes - The main service ground wire was located by the inspector.

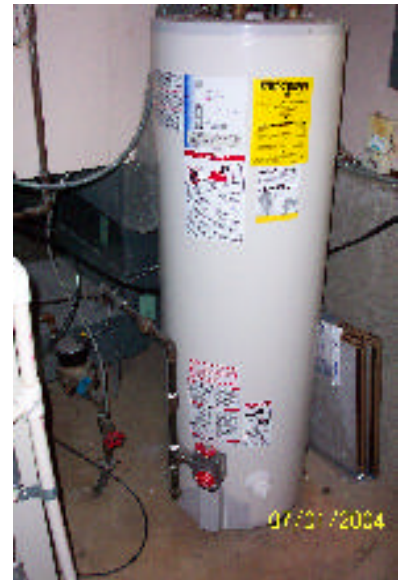
- Water Source:** City/Municipal.
- Plumbing Service Piping Size to Structure:** 3/4" water service line from the meter to the main cutoff.
- Public Service Piping Material:** The main service line to the structure is galvanized.
- Main Water Line Cutoff Location:** Basement laundry room.

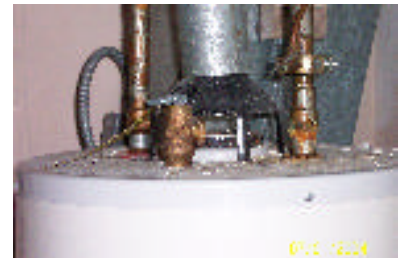
<b>Drain Valve:</b>	Yes - There is a drain valve installed on the lower side of the water heater.
<b>Temperature &amp; Pressure Relief Valve:</b>	Satisfactory - The temperature and pressure relief valve is of the correct rating for the water heater.
<b>Safety Overflow Pipe:</b>	<b>Action Necessary</b> - There is no overflow pipe installed. For safety reasons, immediate installation is needed to help minimize the possibility of serious injury.
<b>Water Heater Insulation Jacket:</b>	No.

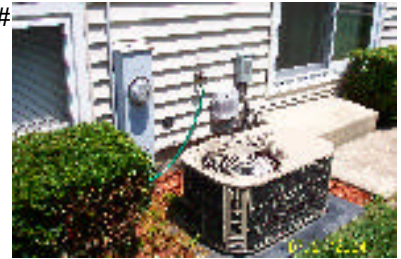
Brand -York ; Model # H2RA036SO6E ; Serial # WALM018711.
